Bellarine Catchment Network

Port Phillip Bay Fund / Litter and Waste Reduction Partnerships

Caring For Our Bays: Litter Hotspot Report

Nov 2017– June 2020

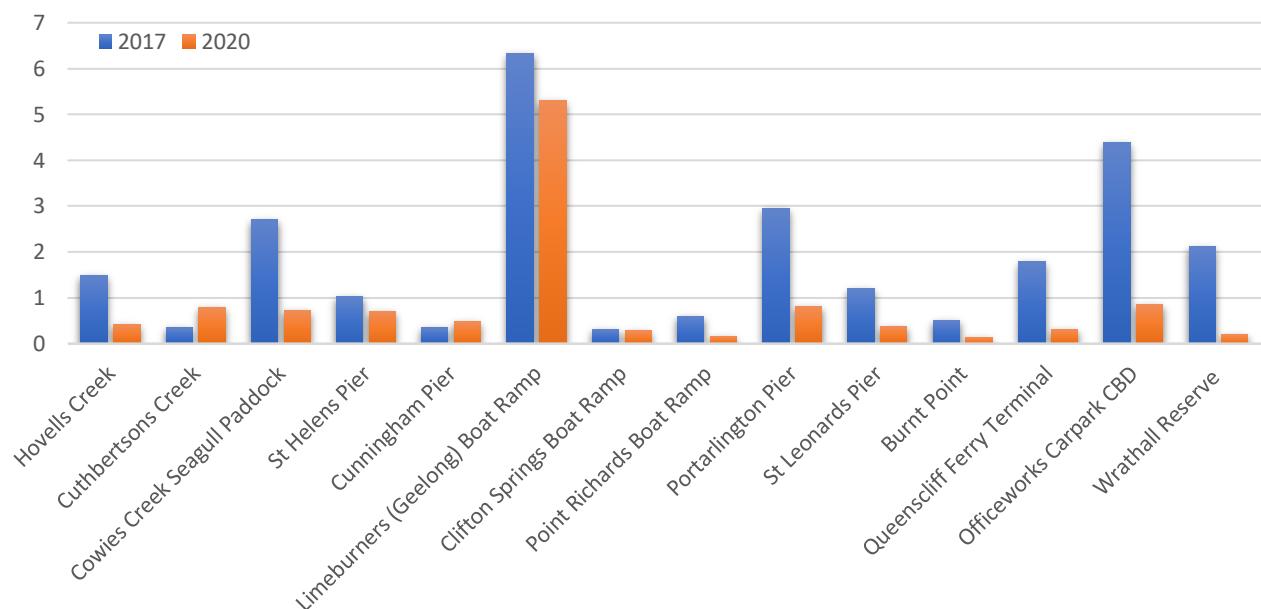
Comparative Abundance of Litter/m² at Hotspot Sites 2017-2020

Limeburners (Geelong) Boat Ramp remains the hotspot with the highest litter abundance at 5.3 pieces of litter/m². All sites except some at Cuthbertsons Creek and Cunningham Pier have decreased in litter abundance since 2017. Six of the fifteen hotspots sites still have litter abundance above 0.5 pieces/m² which will continue to be monitored on a quarterly basis. All other sites have consistently low litter abundance, with some spikes in litter over the Summer holiday period. These sites will be monitored at the end of this Summer period and Winter for comparison and ensure low litter levels are sustained.

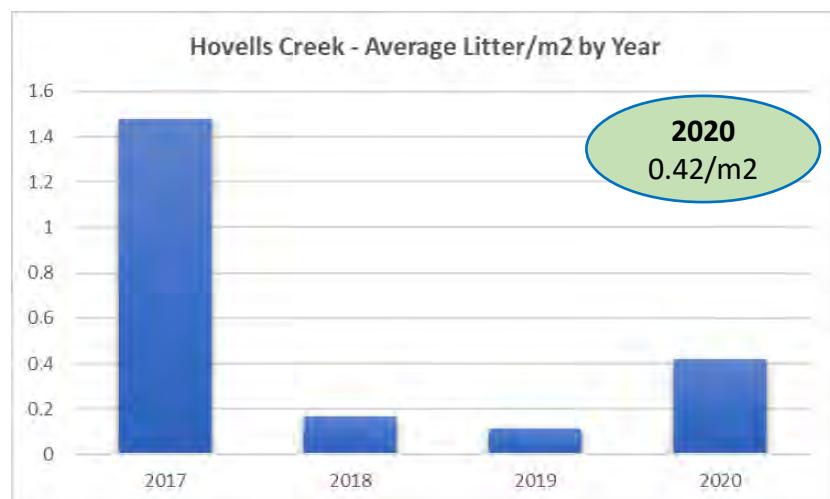
Large decrease by 72% average litter abundance from 2017 to 2020. Decrease in all 3 subsites:

Spike in litter abundance was seen post Covid19 lockdown which may be explained by higher usage of natural areas and eating takeaway in cars as an alternative to dining in.

- Summer/Winter monitoring
- Install butt bin at rotunda seating area
- Continue to conduct education and activities on site and in Northern Geelong.

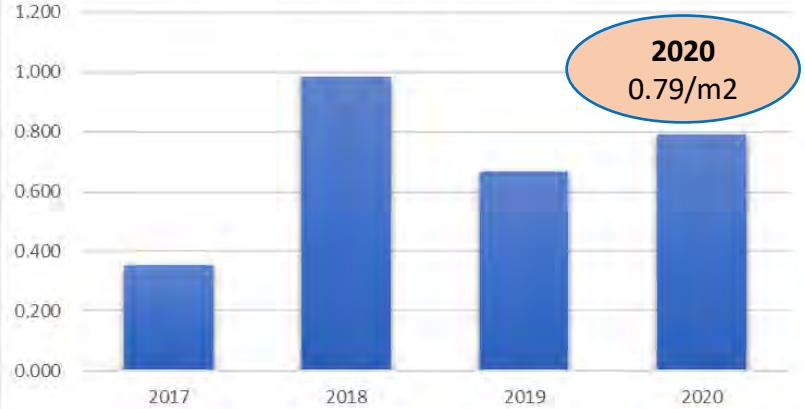
Cuthbertsons Creek - Average Litter/m² by Year

Increase in total average litter abundance from 2017 to 2020.

Decrease seen from 2018 to 2019 post Drivethru signage and partnership with KFC and the fOrT. Increase in 2020 may be skewed due to lack of monitoring during Covid19 lockdown. Increase at 2 subsites:

- Quarterly monitoring
- Continue partnership with KFC and the fOrT and approach McDonalds again
- Continue to conduct education and activities on site and in Northern Geelong
- CFOB signage installation at skatepark
- Litter trap at entrance to channel
- Revegetate riparian areas in association with community, students and fast food staff to increase connection to waterway and increase natural look and appreciation

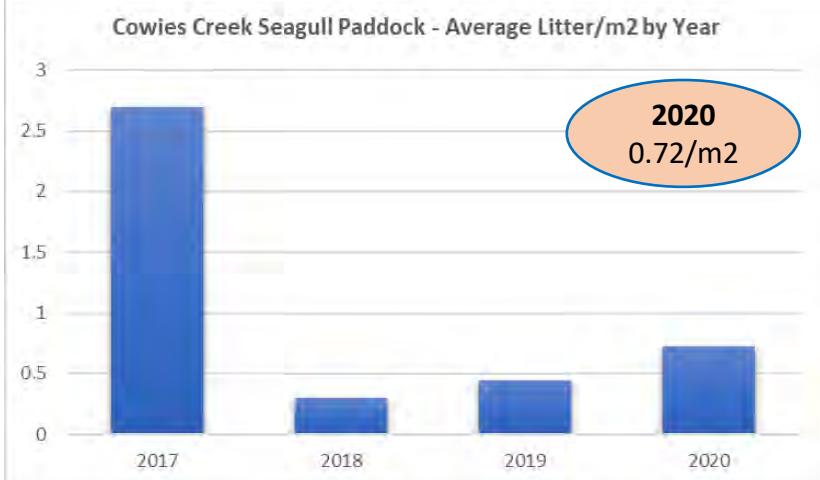
Large decrease by 73% in average litter abundance from 2017 to 2020. Decrease in both sub-sites:

Some spikes in litter abundance were seen during Summer and post Covid19 lockdown period which may be explained by more people accessing takeaway and social distancing eating in their car.

- Quarterly monitoring
- Install butt bin near seating area
- Continue to work with adjacent takeaway outlets to increase awareness and staff clean up days
- CFOB Hero mural installation on toilet block next to carpark

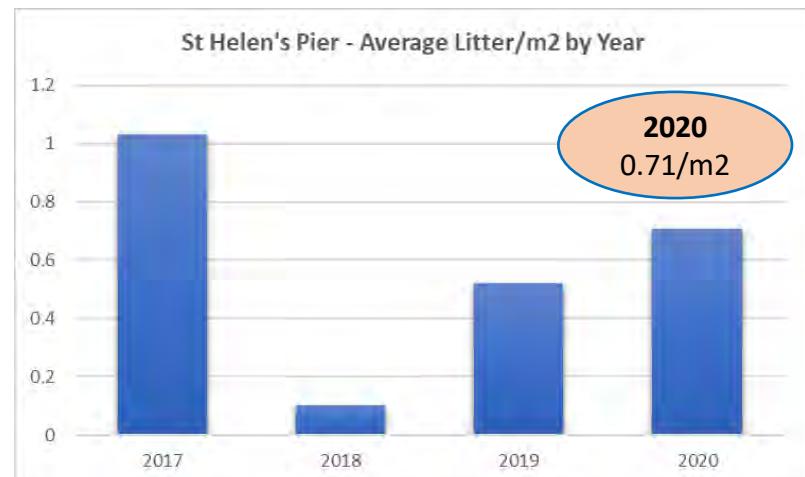
Decrease by 31% in litter abundance from 2017 to 2020. However litter is on an upward trend and post Covid19 which may have been skewed as monitoring was not conducted during lockdown.

A spike in litter was seen during the warmer months due to increased use.

- Summer/Winter monitoring
- Install butt bin at fishing platform
- Work to engage with fishing users to encourage litter reduction. 'I pledge to take my rubbish with me - don't destroy what you came to enjoy! decal on tackle box.

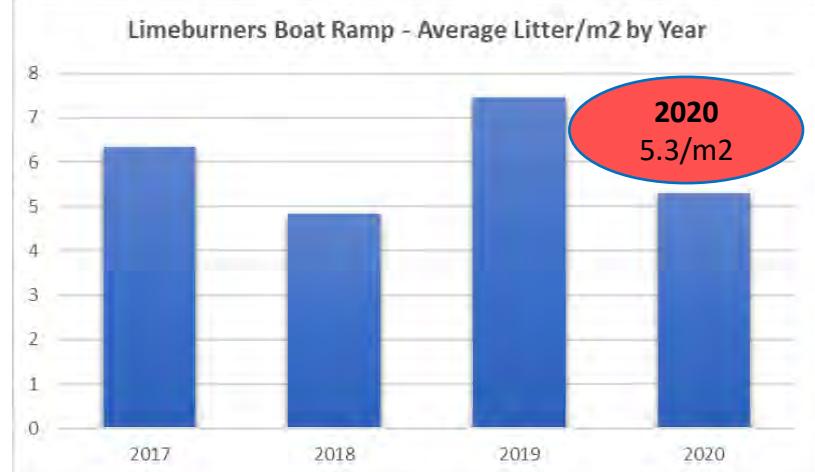
Decrease by 16% in litter abundance from 2017 to 2020. However litter at this site is always high. Covid19 may have impacted data during the 2020 lockdown.

A spike in litter was seen during the warmer months due to increased use.

- Quarterly monitoring
- Install butt bins near fish cleaning table and next to carpark rock wall path
- Install speed hump to reduce hoon use and associated litter items
- Increase lighting to deter parking
- Work to engage with fishing users to encourage litter reduction. 'I pledge to take my rubbish with me - don't destroy what you came to enjoy! decal on tackle box.

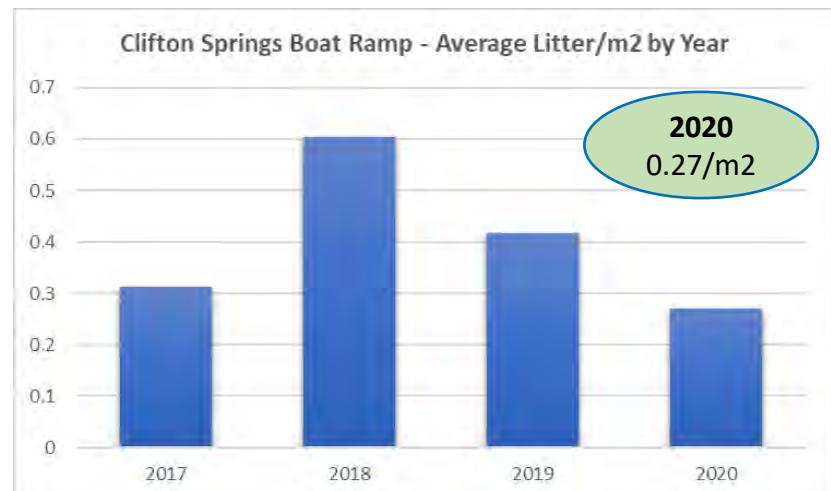
Decrease of 13% in average litter abundance from 2017 to 2020 with a overall low litter abundance seen throughout the year. Peak litter occurs during Summer and Easter holiday periods. Clear downward trend in litter since 2018.

- Summer/Winter monitoring
- Install LOTE signage
- Continued support for City of Greater Geelong and Coastcare group to conduct education activities and on-ground action with schools and community.

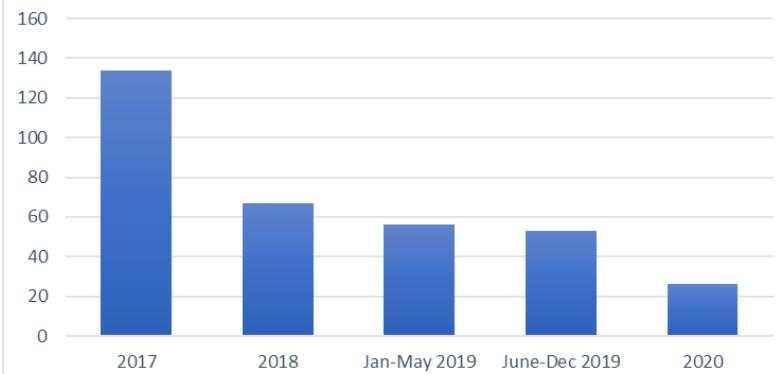
Average Monthly Cigarette Abundance 2017-2020
Before and after butt bin installation

Other items addressed have been parking ticket receipts which people would litter as they came back to the carpark as there are no bins available. A bin was added next to the parking refund machine in the Officeworks entry and CFOB posters and litter information highlighted. This saw a decrease of 90% in parking tickets and receipts being found during audits.
